DEPARTMENT OF TRANSPORTATION

Contract #: 04-0120F4Cty: SF/ALA Rte: 80 PM: 13.2/13.9File #: 1.28**WELDING INSPECTION REPORT****Resident Engineer:** Casey, William**Address:** 333 Burma Road**City:** Oakland, CA 94607**Report No:** WIR-029871**Date Inspected:** 26-Jul-2013**Project Name:** SAS Superstructure**OSM Arrival Time:** 700**Prime Contractor:** American Bridge/Fluor Enterprises, a JV**OSM Departure Time:** 1730**Contractor:** American Bridge/Fluor Enterprises, a JV**Location:** Job Site

CWI Name:	Jesus Cayabyab, Bernie Docena	CWI Present:	Yes	No
Inspected CWI report:	Yes No N/A	Rod Oven in Use:	Yes	No N/A
Electrode to specification:	Yes No N/A	Weld Procedures Followed:	Yes	No N/A
Qualified Welders:	Yes No N/A	Verified Joint Fit-up:	Yes	No N/A
Approved Drawings:	Yes No N/A	Approved WPS:	Yes	No N/A
		Delayed / Cancelled:	Yes	No N/A
Bridge No:	34-0006	Component:	SAS Tower

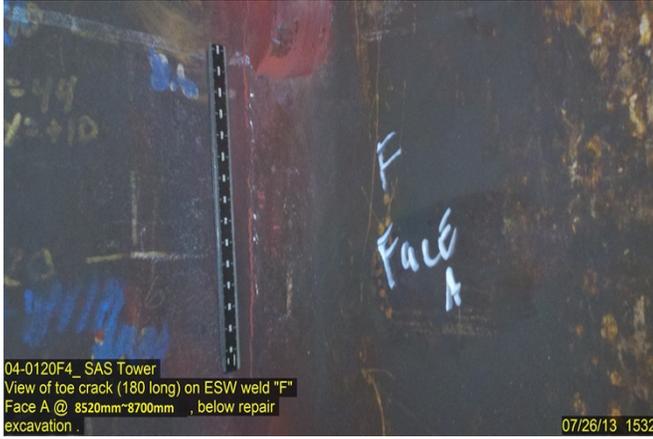
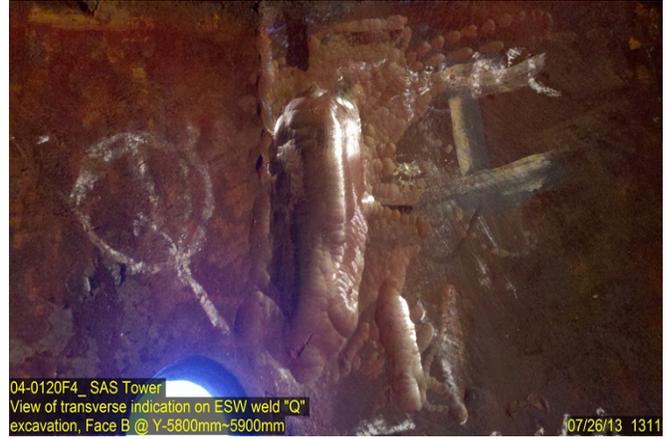
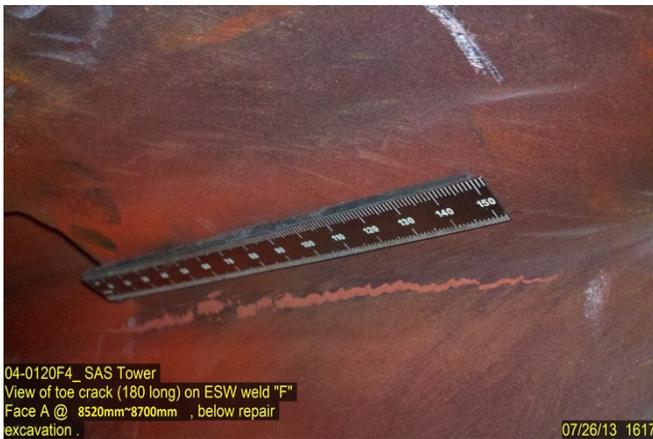
The QA Inspector observed, at random intervals, ABF/JV welder Don Plumb (WID-0891) performing grinding excavation of Electroslag Weld (ESW) "Q" face B, to verify indications observed during Ultrasonic Testing. After grinding to bright metal the QC Inspector performed MT testing of the excavation to inspect for the indications at each hold point. The QA Inspector also performed MT inspection throughout the process and the final excavation.

Weld excavated at 6mm-Transverse indication.

Weld excavated at 10mm-Transverse indication.

Weld excavated at 12mm-Transverse indication, planar indication.

Weld excavated at 15mm- Transverse indication, planar indication.

Weld excavated at 18mm- Planar indication.

Weld excavated at 20mm-No indication observed.

Excavation -L= 90mm, W= 20mm, D= 15mm

The QA Inspector observed, at random intervals, ABF/JV welder Mike Jimenez (WID-4671) performing weld repairs of the repair excavation on Electroslag Weld (ESW) "V", at face B locations noted as:

The welder was observed preheating the weld to over 300° Fahrenheit prior to welding using the Miller ProHeat 35 with heat induction blankets. The welder was using 4.0mm diameter electrode (E7018-MH4-R) per ABF Welding Procedure Specification (WPS) ABF-WPS-D15-1000-Repair Rev.3 for Shield Metal Arc Welding (SMAW). The welding parameters were verified by QC Inspector Bernie Docena throughout the day and appeared to be in compliance with the WPS noted above.

The QA Inspector was later present to observe ABF welder Kit Lai (WID-2953) performing exploratory excavation of ESW "F" Face A @ Y-8790mm, 8960mm to verify indications observed during Ultrasonic Testing pulse/echo & pitch/catch. Mr. Lai was assisted by ABF Welder apprentice Simon Ma who performed the grinding on the excavation. ABF QC Inspector Jesse Cayayab stated that Mr. Ma will excavate every 3mm deep and allow QC/QA to inspect the excavation. Location of the repair is as follows:

After grinding to bright metal the QC Inspector performed MT testing of the excavation to inspect for planar indications at each hold point. After initial MT, The QC Inspector and QA Inspector noted that there was a linear longitudinal at the bottom of the excavation that ran for approx. 180mm long. The indication appeared to be a toe crack on the surface of the ESW weld @ 8520mm~8700mm. Mr. Cayabyab stated that he would document the info for the toe crack and pass along to ABF. The QA Inspector also informed SMR Aaron Prchlik of the excavation. See TL-6028 for additional details on items inspected.
